Formal inspection: Tree survey report for Chelmondiston Parish Council, covering Page's Common and Pin Mill Common.

Date: 6th October 2021

Surveyor: Lee Foster

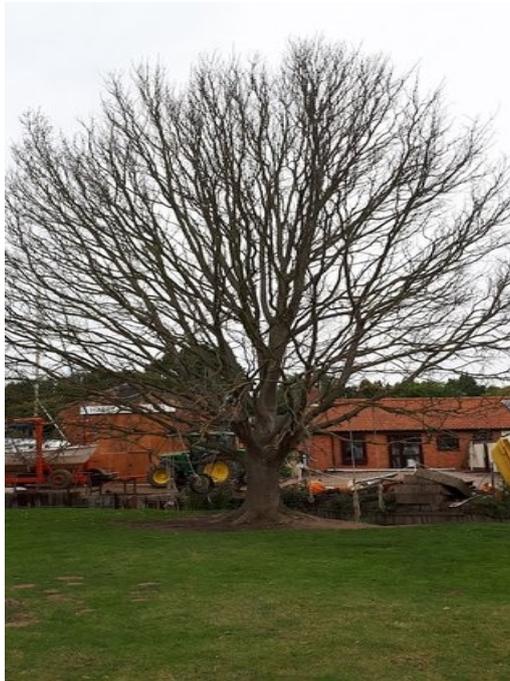
Location: Right hand side of Common.

Z1T1: Oak. For the second year running there has been no leaf cover in the crown, which is thought to have been the result of numerous salt water flooding events onto the common (other Oaks in the area still have a full canopy). Samples of twigs were taken, and when broken, very few showed any significant signs of life. The extremities of a few of the lower branches had some stunted growth, however there was flaking bark and dead / broken branches higher up, and some on the ground. There was also evidence of boring insect damage, which often happens once a tree starts to die.

A number of rope swings exist which have caused minor damage to the bark / cambium layer, but makes the tree a focal point.

Zero canopy, while other Oaks in the area have a fully canopy.

Risk rating: High

Action: 1) Reduce the tree down to its main structural framework, as the Oak will be able to stand for many decades, and it does have significant amenity values, both physically and aesthetically.

2) As the custodian of the tree, the Parish Council may feel that the swings should be removed as they do not meet any safety standard, although this could be considered an unnecessary action as the tree has been used for children’s swings for generations, and are a “feature” of the common.

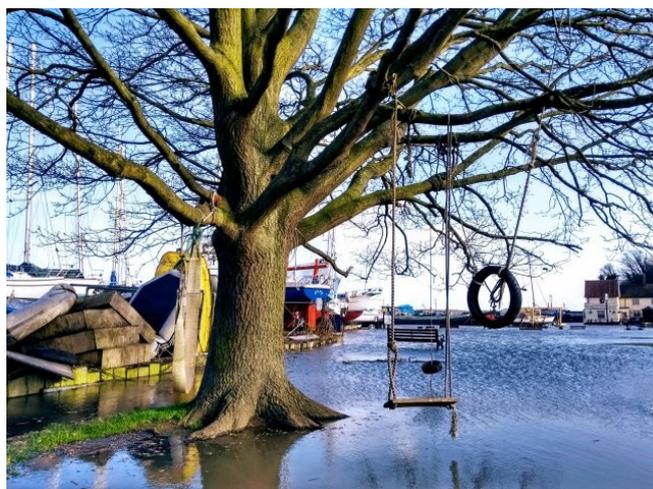
View of the common / Oak during a high tide.

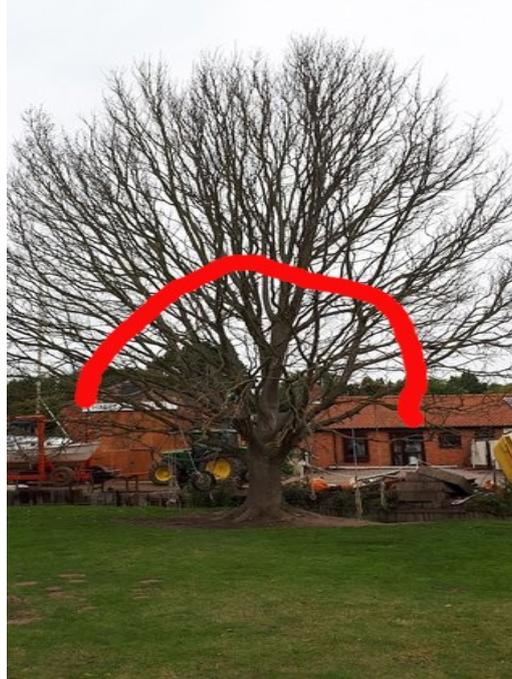
It is not impossible that the tree may put some epicormic growth on once the branches are removed and it has had a few years to recover, but with the inability to photosynthesise, and probable more salt water flooding, the likelihood of it becoming a “full tree” again is remote.

Remove branches down to approximately the height of the red line, and also remove any smaller branches, such that only main structure remains.

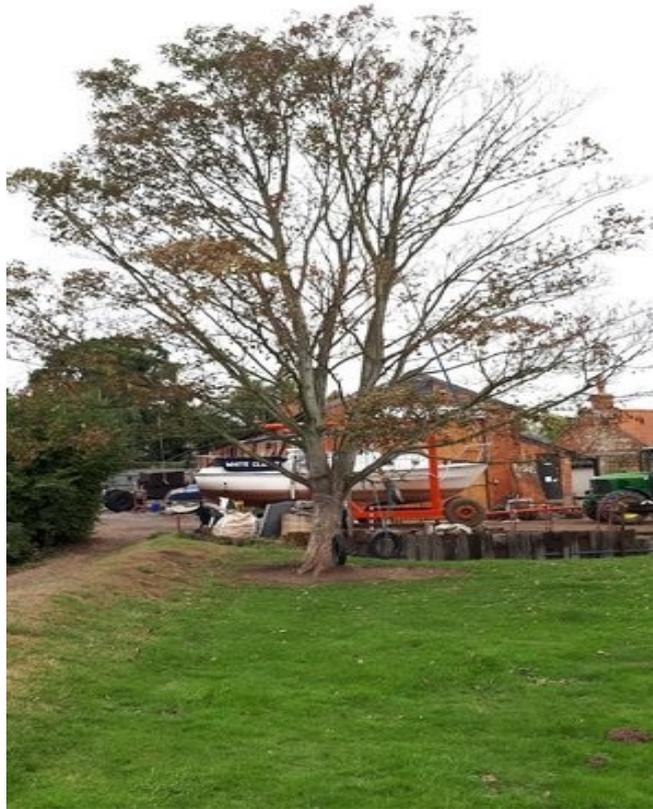
Location: Bottom right hand side of Common.

Z1T2: Sycamore. Similar premature leaf fall / weak canopy formation has been observed previously, which again is probably due to an intolerance to the salty environment that the tree is in. A couple of branches had no leaves, and exhibited flaking bark, indicating they have died.

There are rope swings in this tree also.

Risk rating: Medium.

Action: Remove dead branches and monitor future canopy formation.

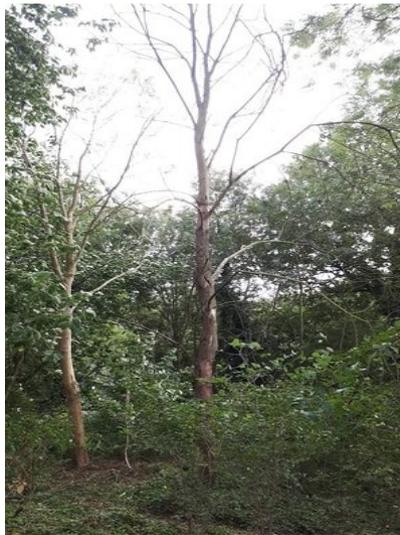
Location: At top end of Page's Common, near the "forest school" area. (Z2T2 can be seen to the left).

Z2T1: Elm. Elm tree suffering from Dutch Elm disease. Trees with Dutch Elm disease support a number of invertebrate species, which in turn support other wildlife and add to the bio-diversity, so where possible it is good to be able to keep them, however this one has now been in this condition for a number of years, and the root plate felt unsecure.

Risk rating: Medium.

Action: Fell – leave a high stump, as it is suspected that Stag Beetle larva are probably in the root, causing the insecurity of the root plate.

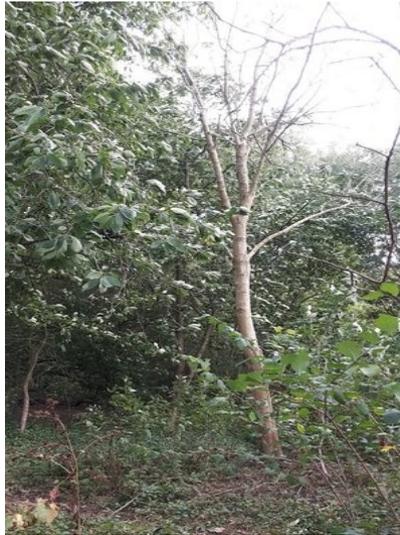
Location: Adjacent to Z2T1.

Z2T2: Ash. Ash tree suffering from Ash Dieback. A very poor canopy was evident, and there is significant animal damage and decay in the basal area.

Risk rating: Medium.

Action: Fell – leave a high stump, as it is suspected that Stag Beetle larva are probably in the root.
